Final
Cultural Landscape Report
Volume 1

Pahaquarry Copper Mine
DELAWARE WATER GAP

August 1995

by
Steve R. Burns Chavez
A. Berle Clemensen

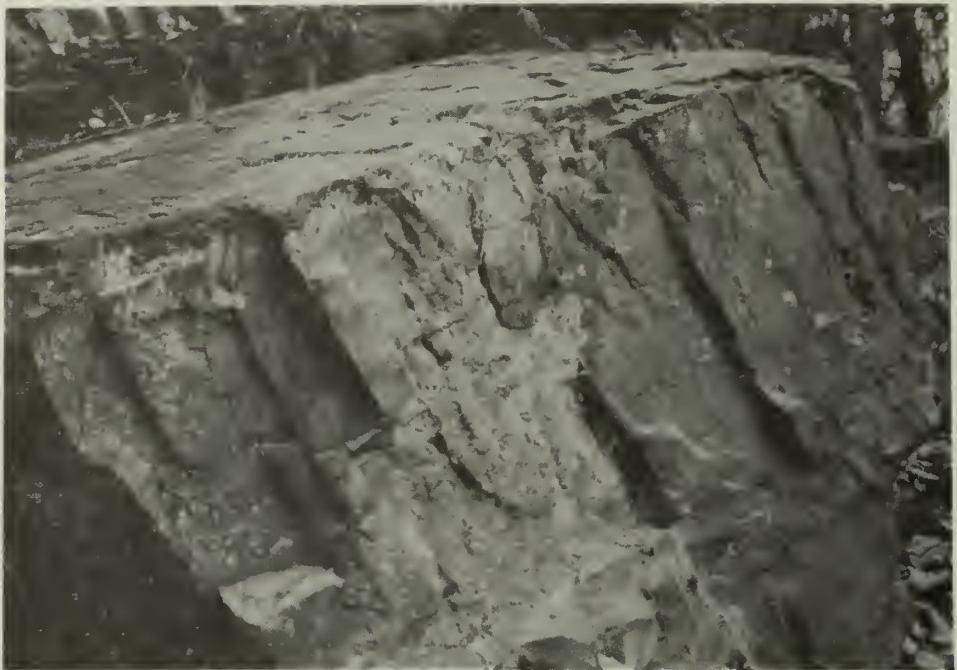
Figure 6B Photo 36
Colonial mine adit across from lower tunnel no. 1 above Minebrook.

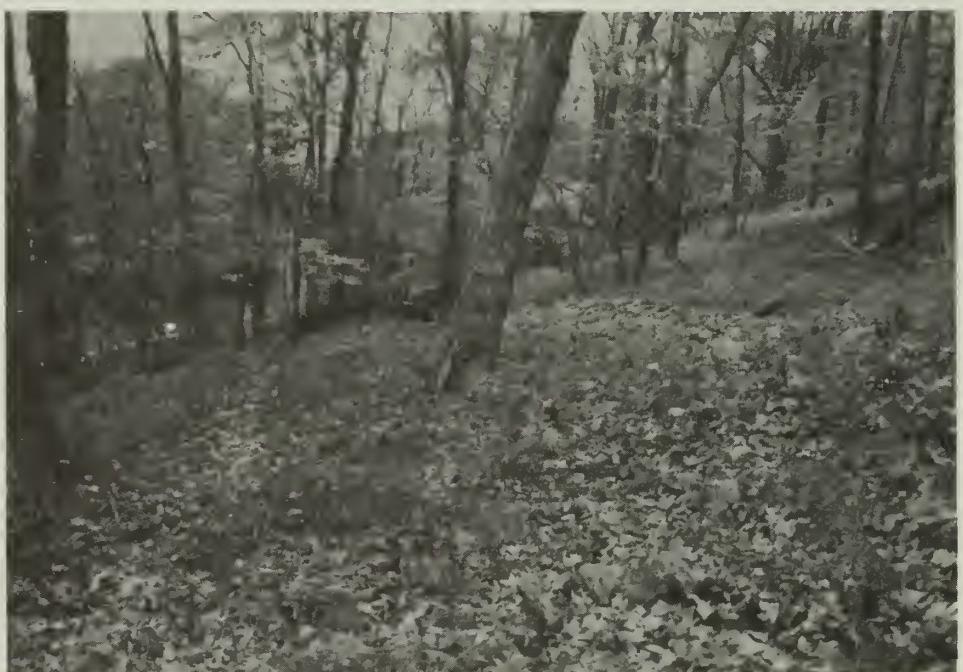
Figure 6B Photo 37
Closeup of rock at colonial mine adit across from lower tunnel no. 1 above
Minebrook

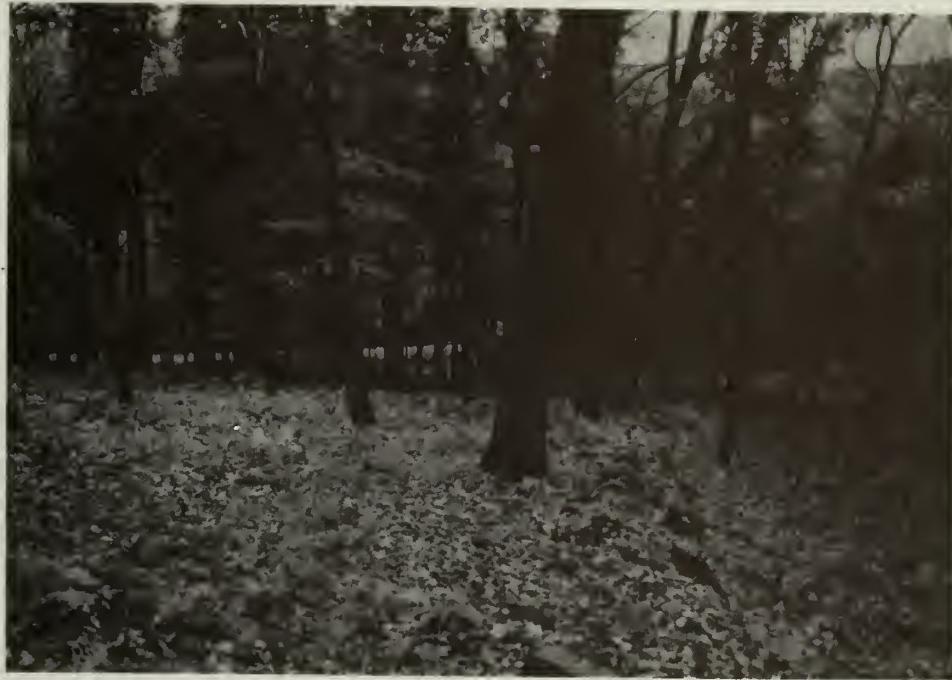
Figure 6B Photo 38
Rock pile probably from early 1800s field wall moved by Boy Scouts. West of
Minebrook above old mine road

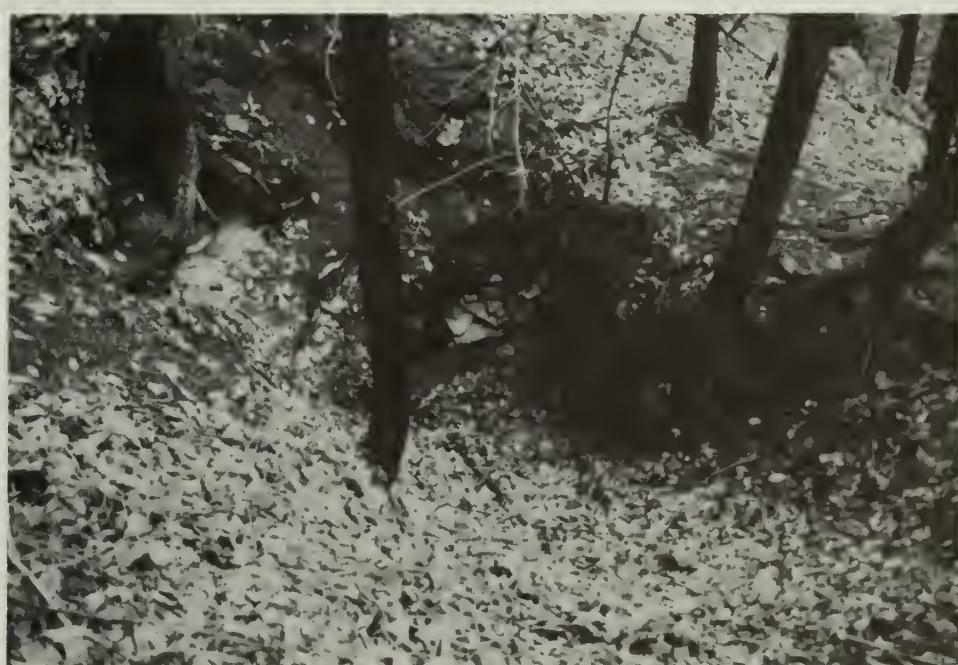
Figure 6B Photo 39
Stone field wall probably early 1800s on upper river terrace on former
Shoemaker land.

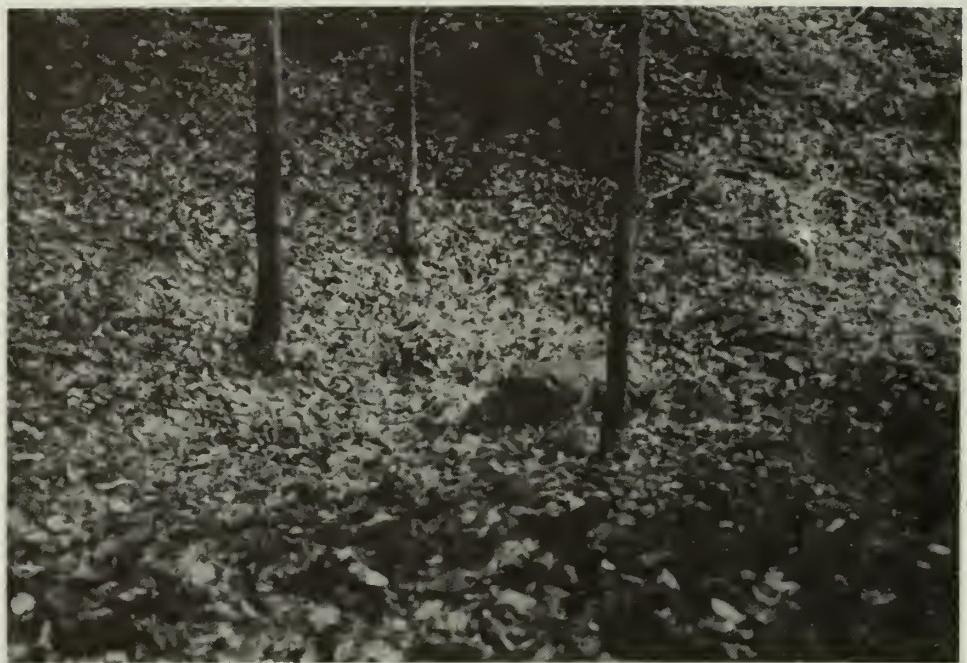
Figure 6B Photo 40
Probable 1750s period exploratory shaft in ravine on the east side of Minebrook

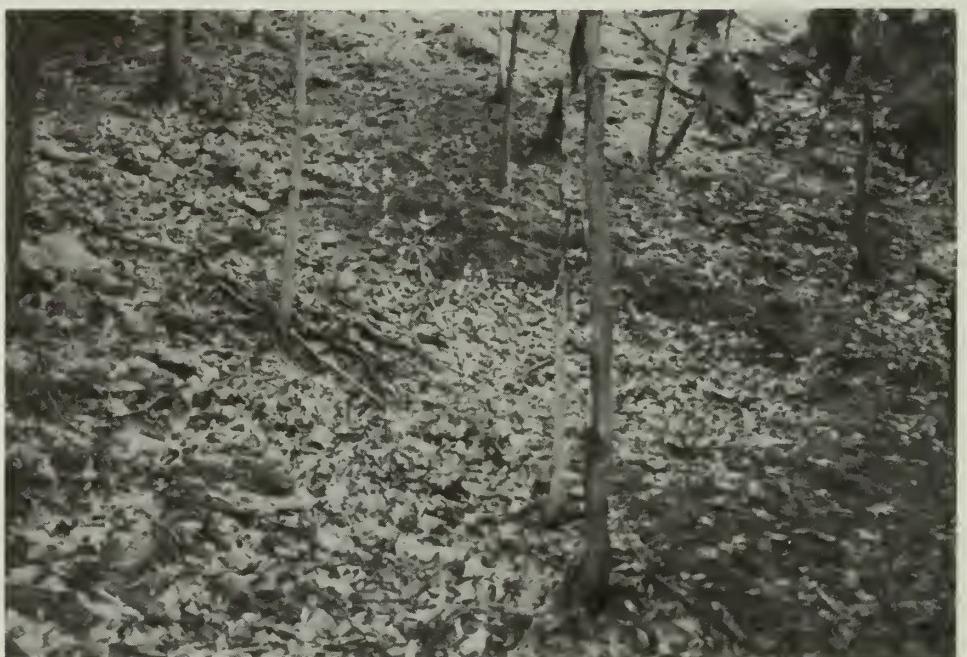
Figure 6B Photo 41
Probable 1750s period exploratory shaft in ravine on the east side of Minebrook

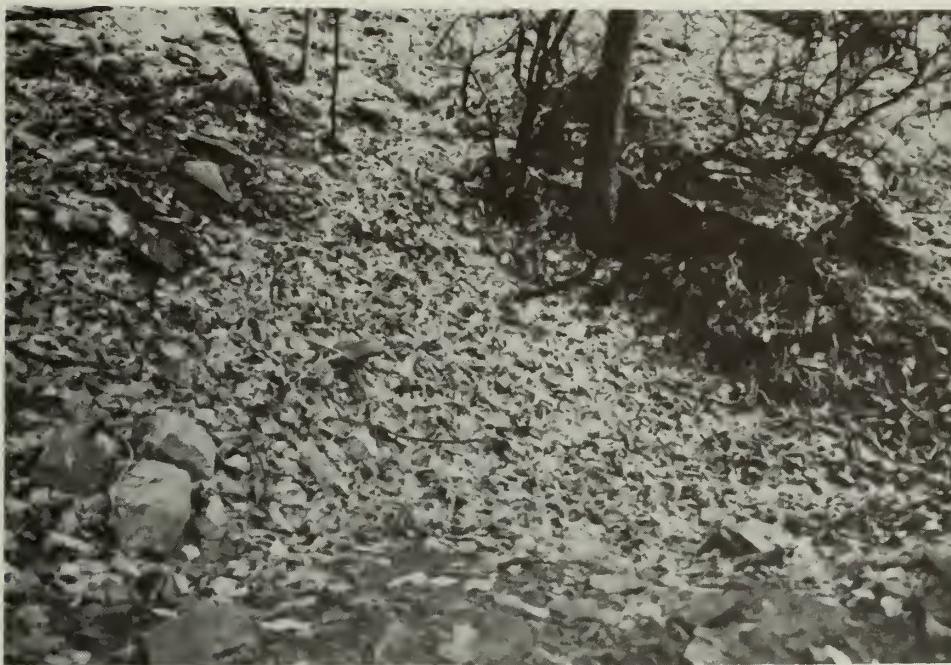
Figure 6B Photo 42
Probable 1750s period exploratory shaft in ravine on the east side of Minebrook

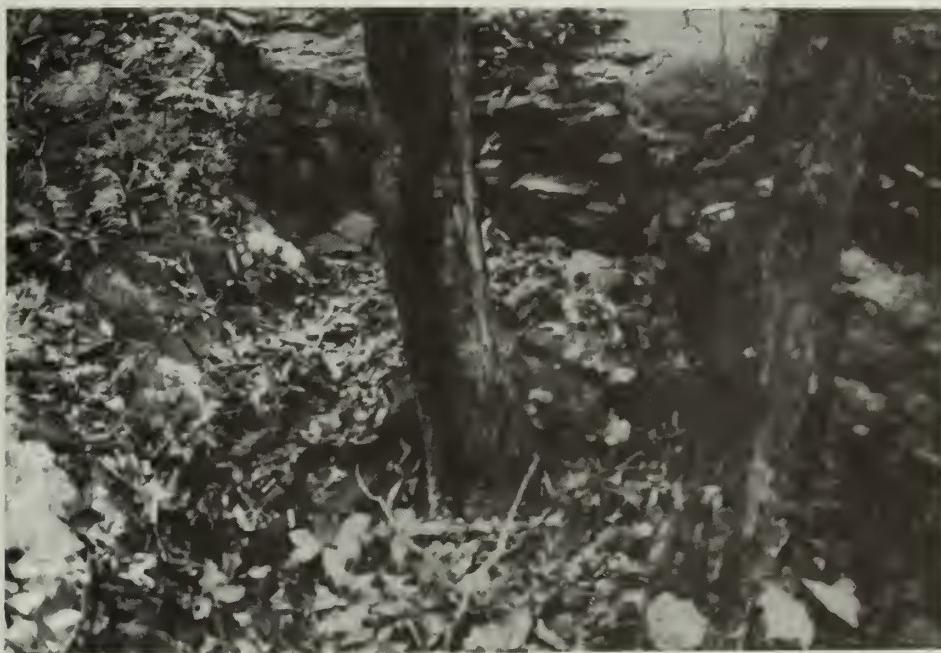
Figure 6B Photo 43
Probable 1750s period exploratory shaft in ravine on the east side of Minebrook

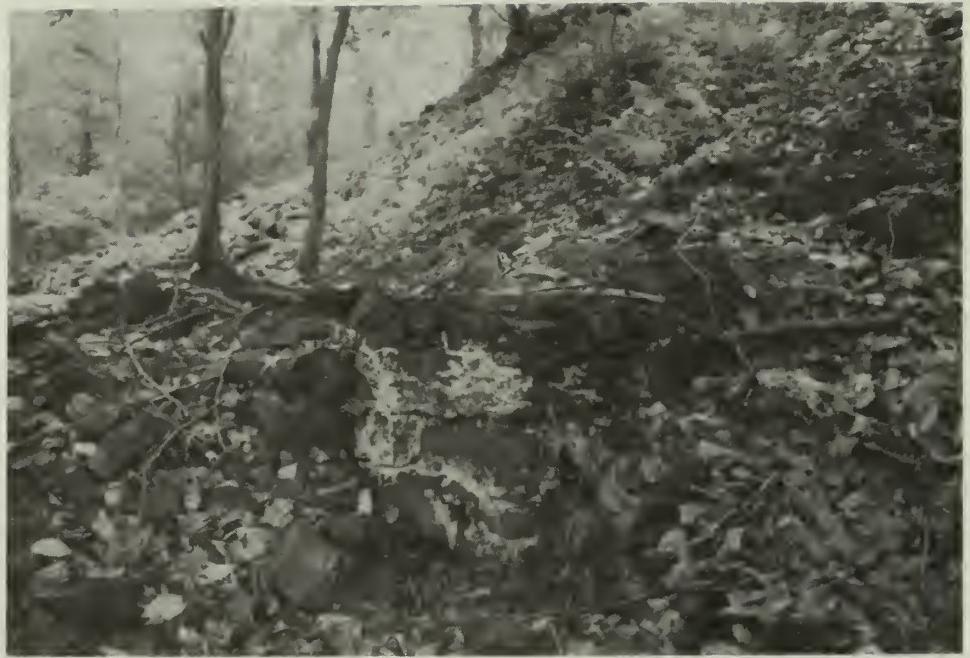
Figure 6B Photo 44
Probable 1750s period exploratory shaft in ravine on the east side of Minebrook

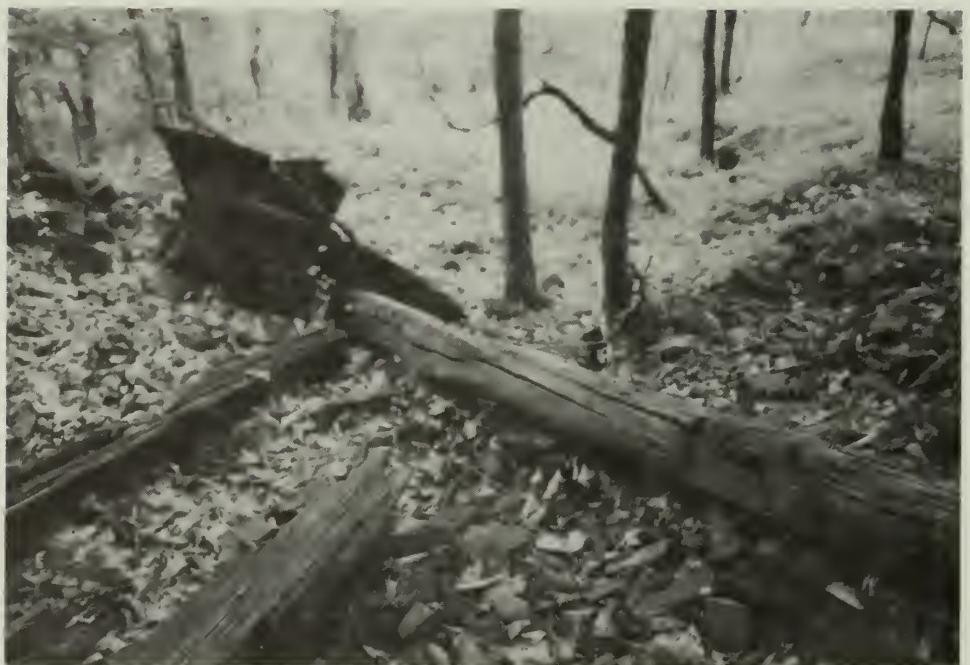
Figure 6C Photo 1
1908 remains of tipple building west wall

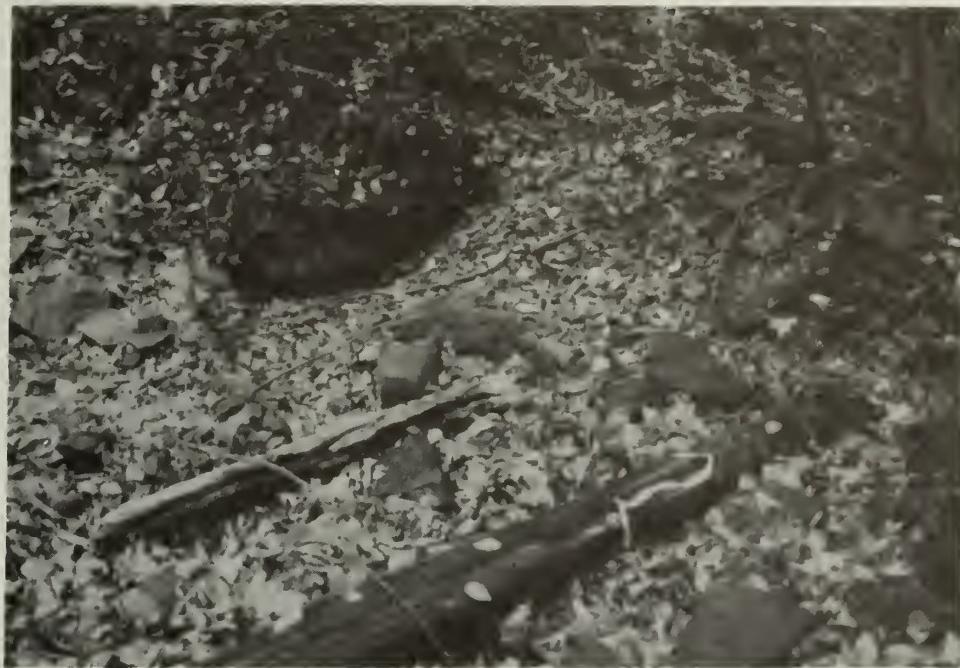
Figure 6C Photo 3
1908 in situ floor foundation and south stone wall remains

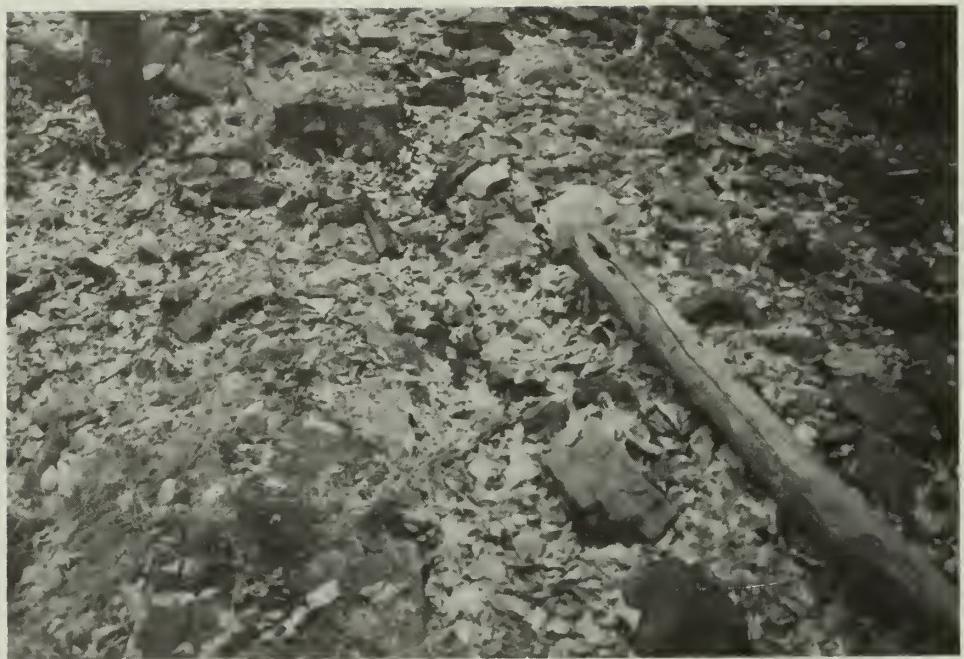
Figure 6C Photo 4
1908 spoil pile above tipple building site

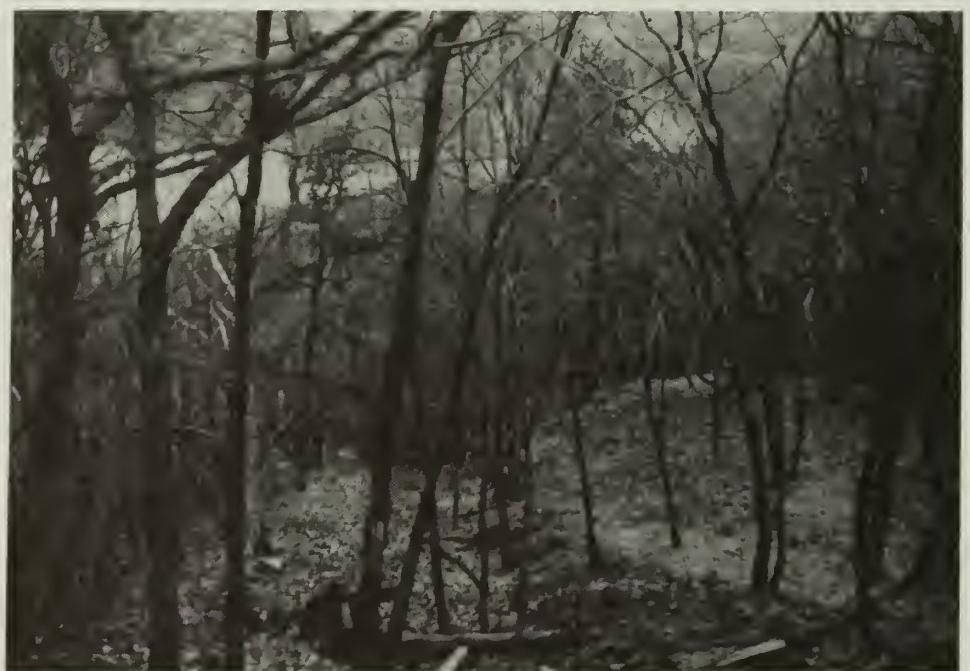
Figure 6C Photo 5
1908 in situ remains of tipple building east wall

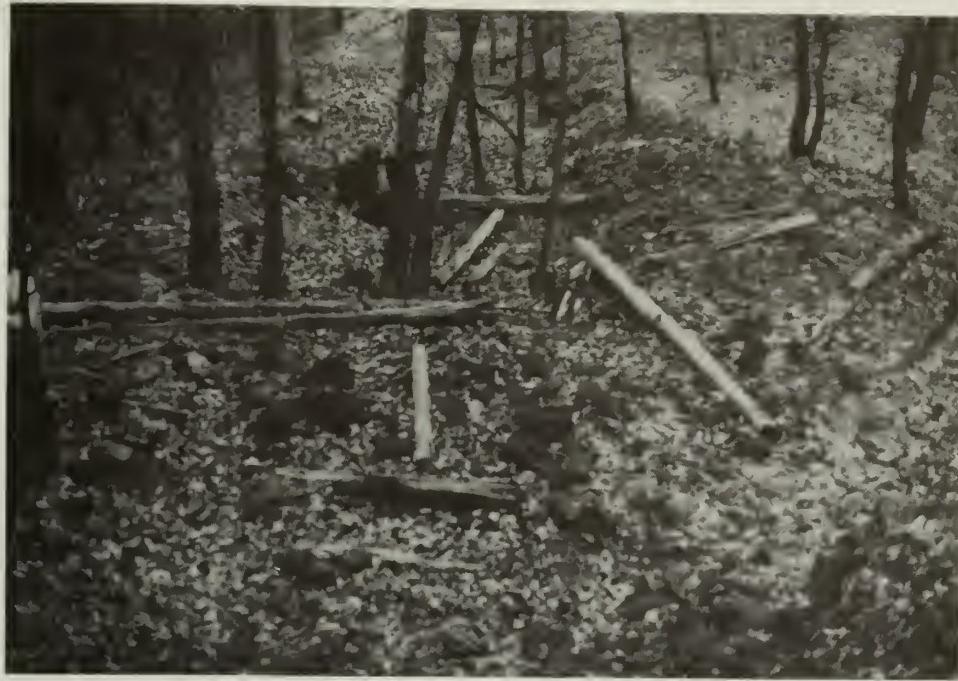
Figure 6C Photo 6
1908 remains of track bed of train from tipple building ore bucket in foreground

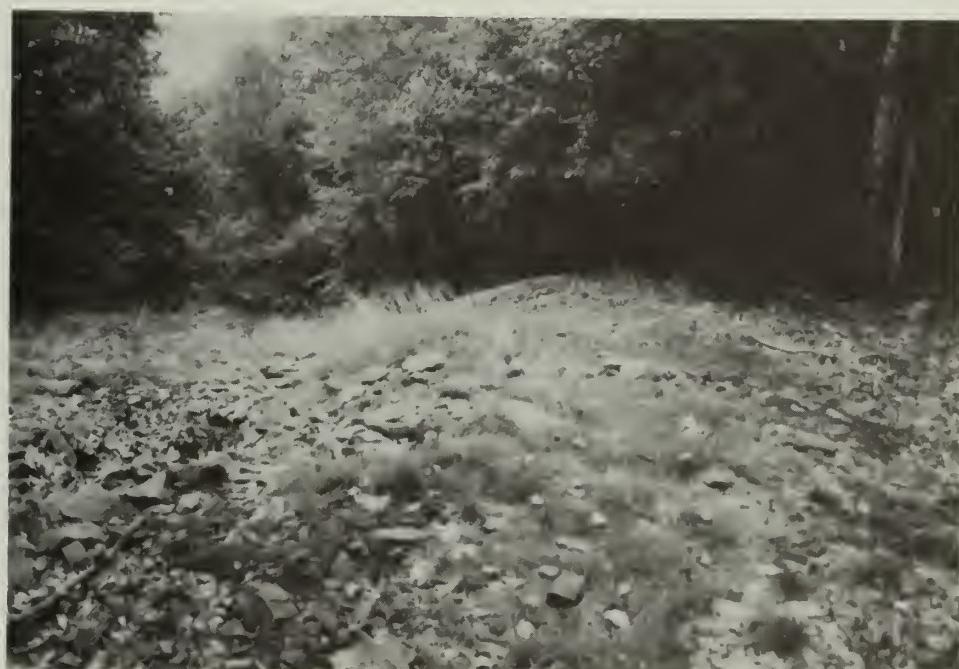
Figure 6C Photo 6
1908 remains of tipple building and track bed of train from spoil pile above

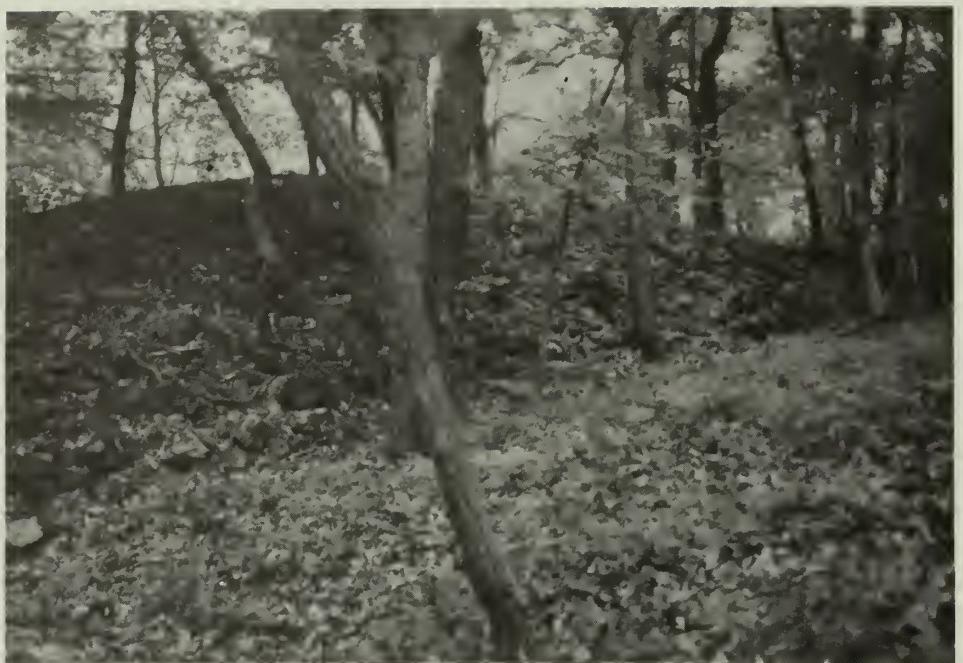
Figure 6C Photo 7
1907-1911 track trace on spoil pile

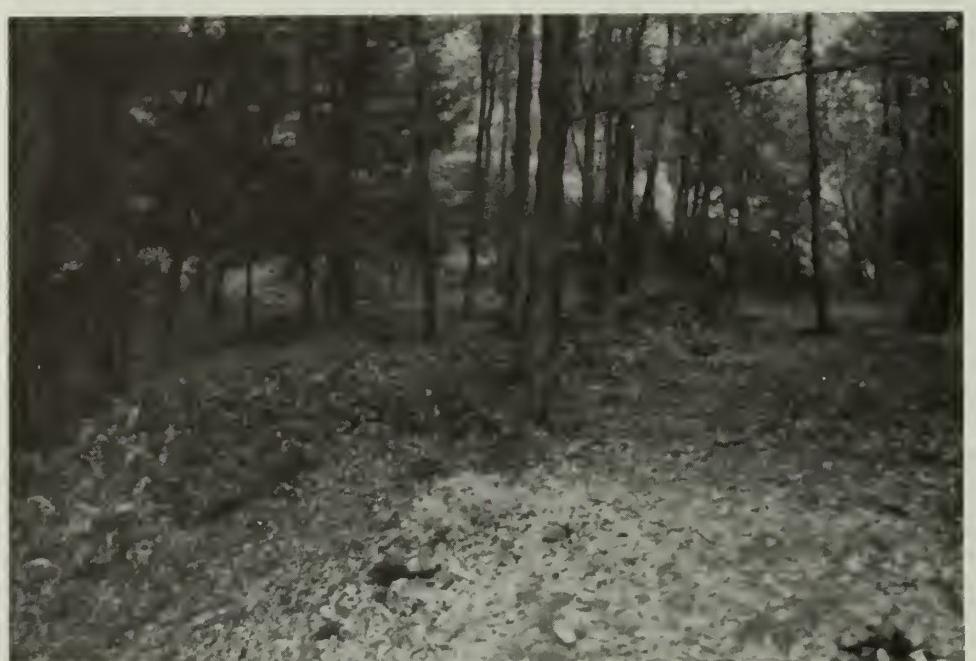
Figure 6C Photo 8
1909-1911 spoil material from the quarry

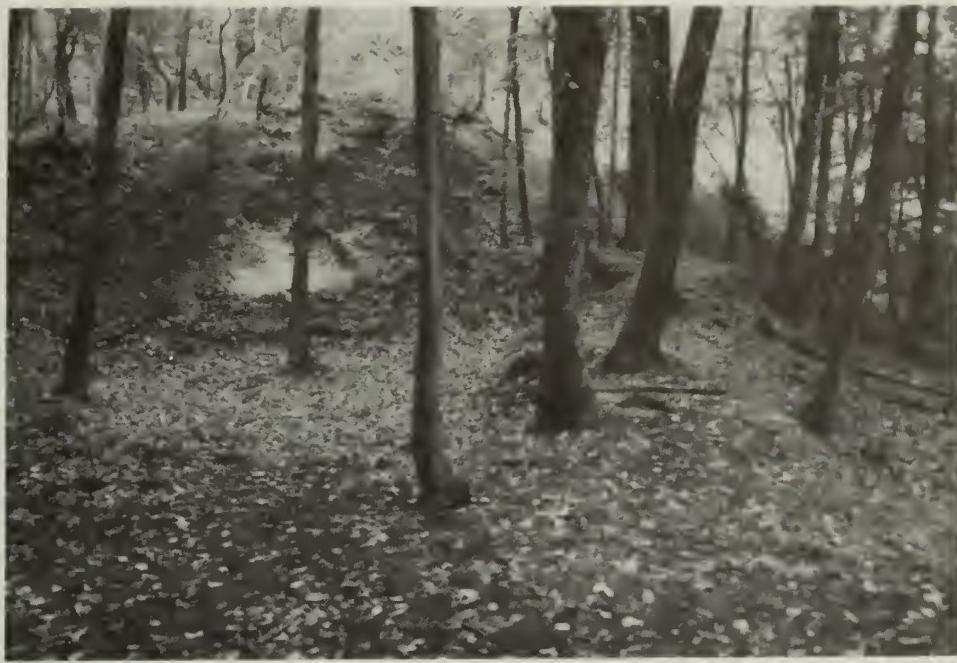
Figure 6C Photo 9
1909-1911 area from quarry site to spoil pile

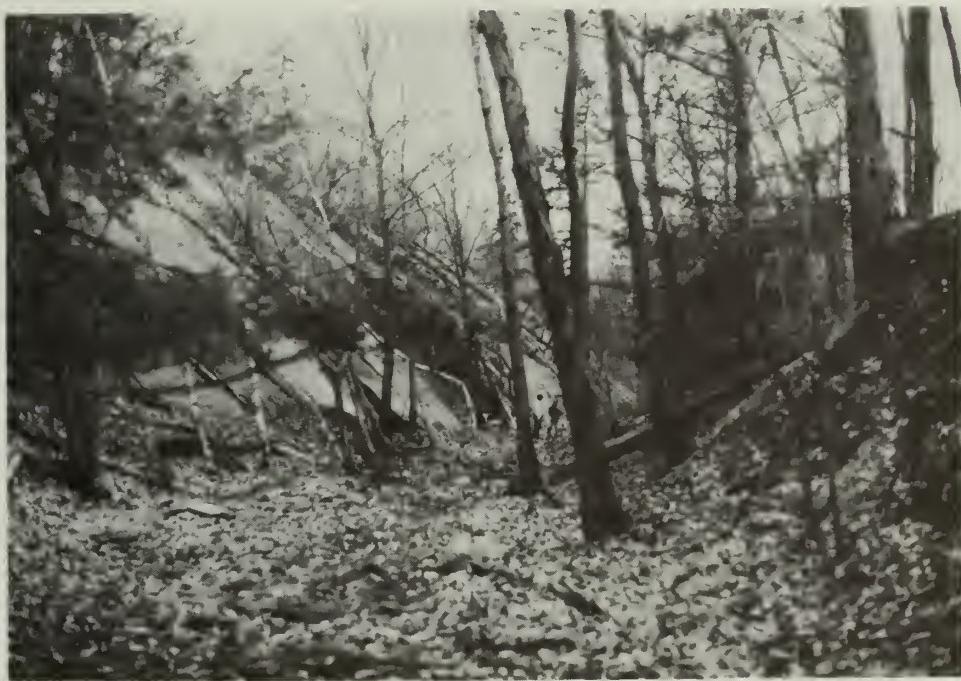
Figure 6C Photo 10
Probable 1900s period grading work at quarry site entrance

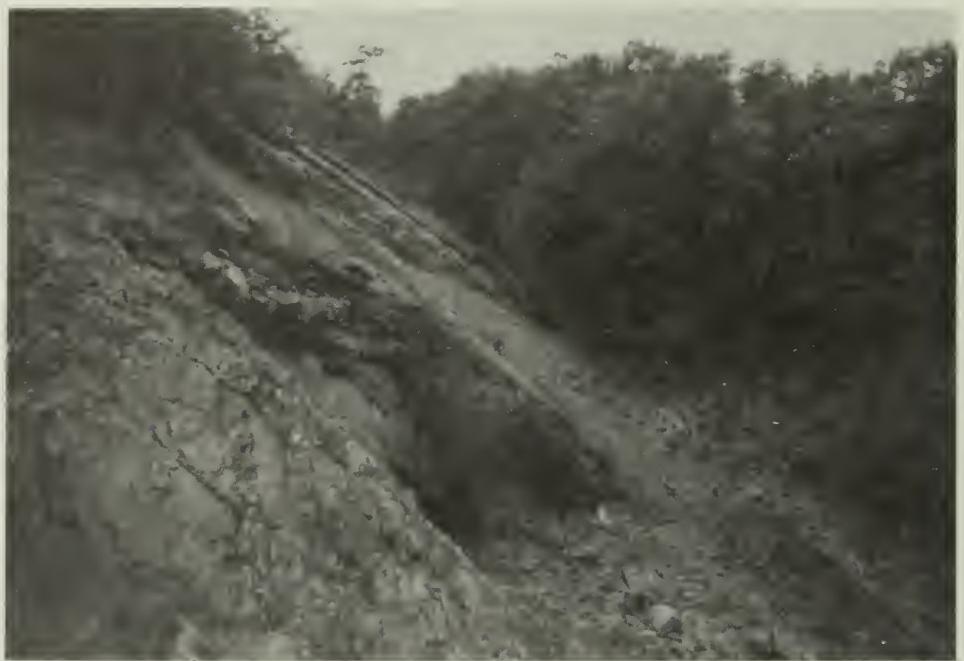
Figure 6C Photo 11
1909-1911 quarry site

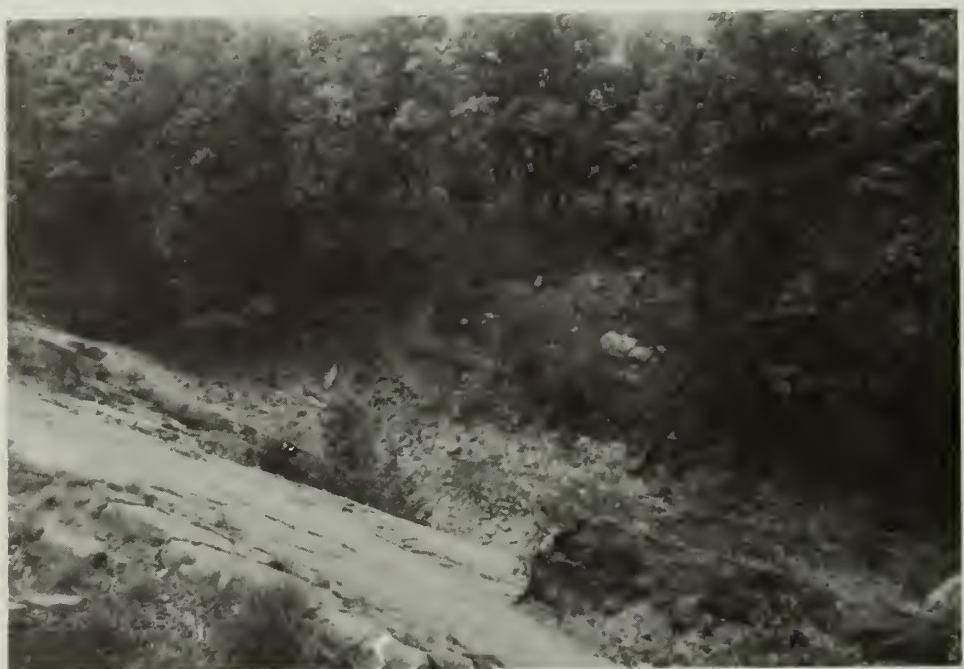
Figure 6C Photo 12
1907-1911 quarry site

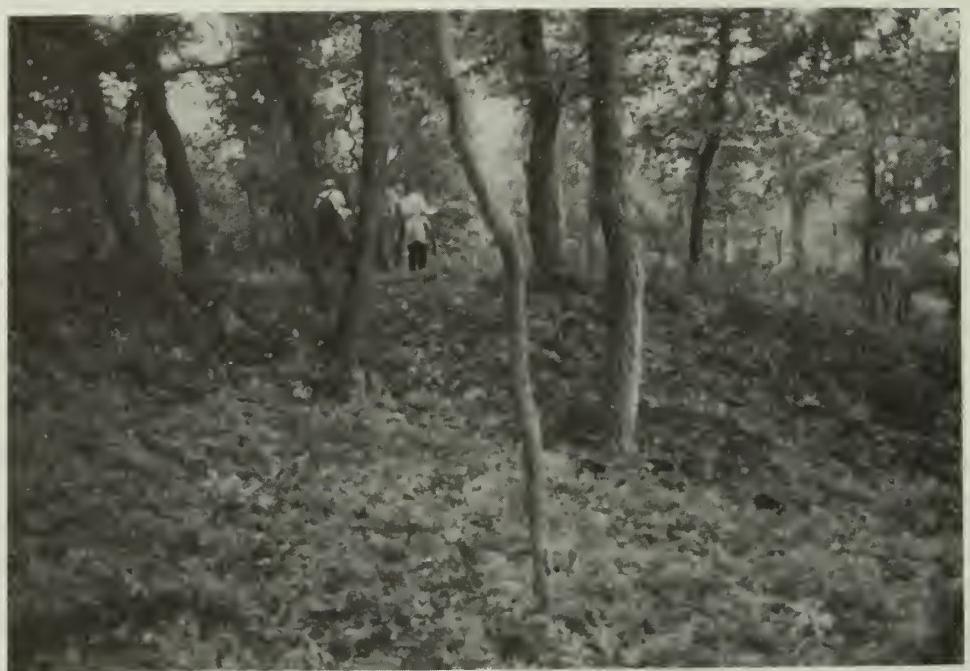
Figure 6C Photo 15
1907-1911 quarry from south end

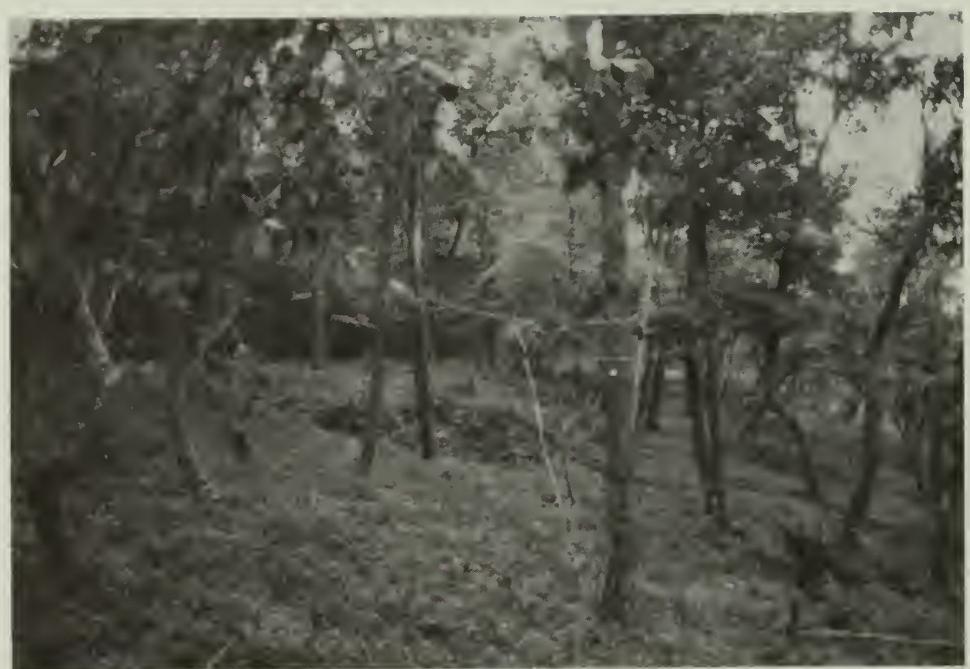
Figure 6C Photo 16
1909-1911 tailings northwest from quarry

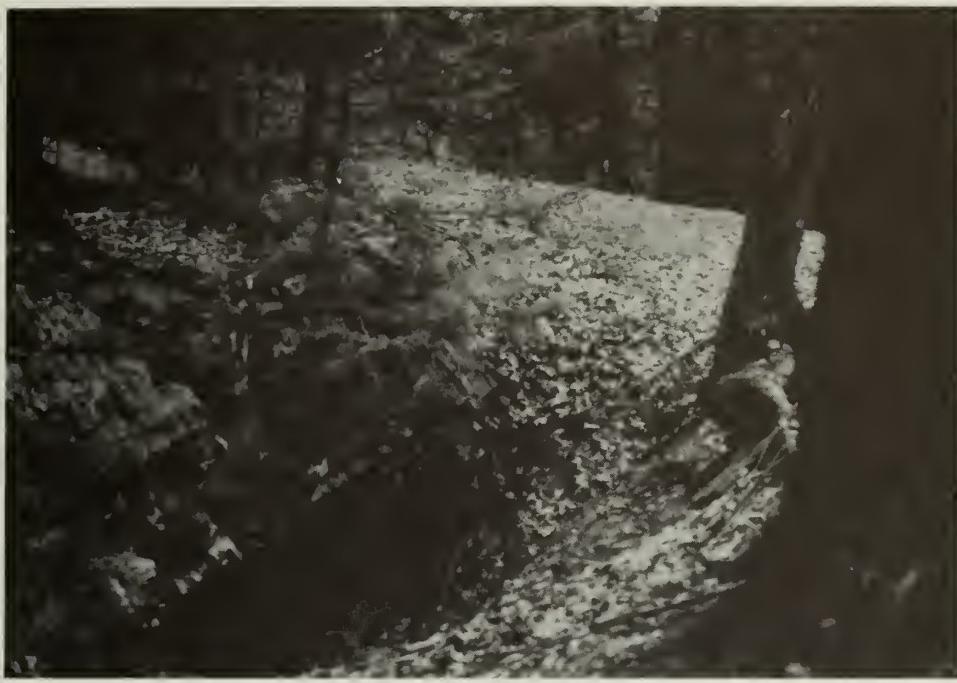
Figure 6C Photo 17
1909-1911 tailings northwest from quarry

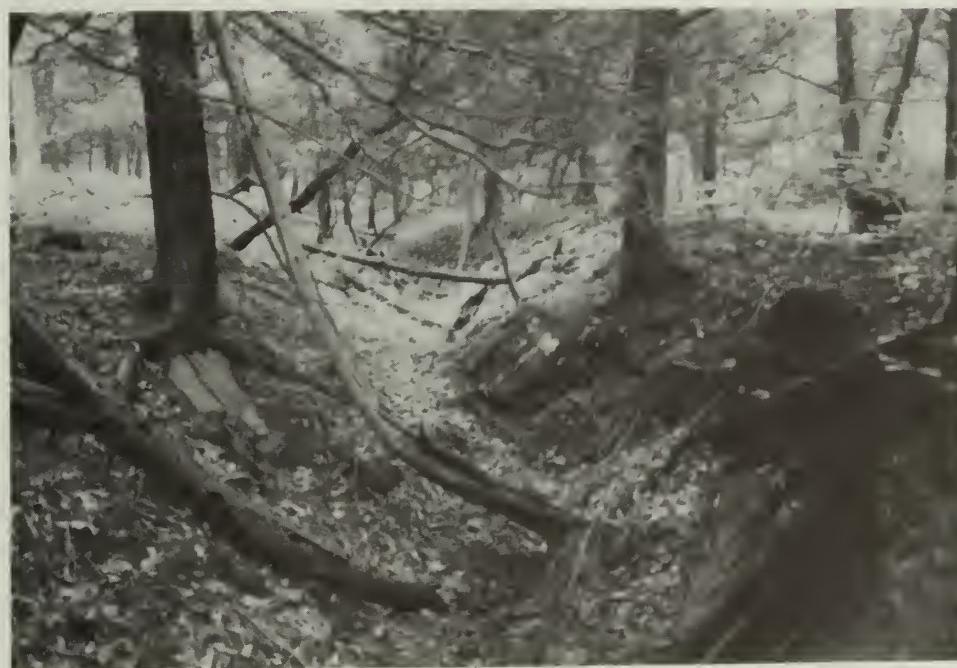
Figure 6C Photo 18
1847-1862 period shaft number 5

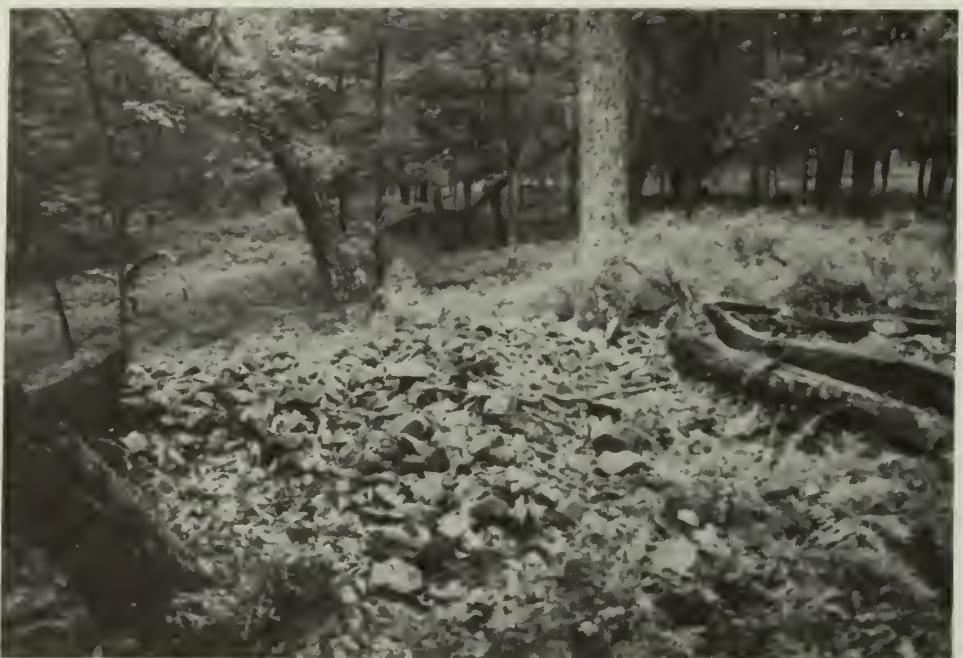
Figure 6C Photo 19
1947-1862 period trench number 7 from incline 6

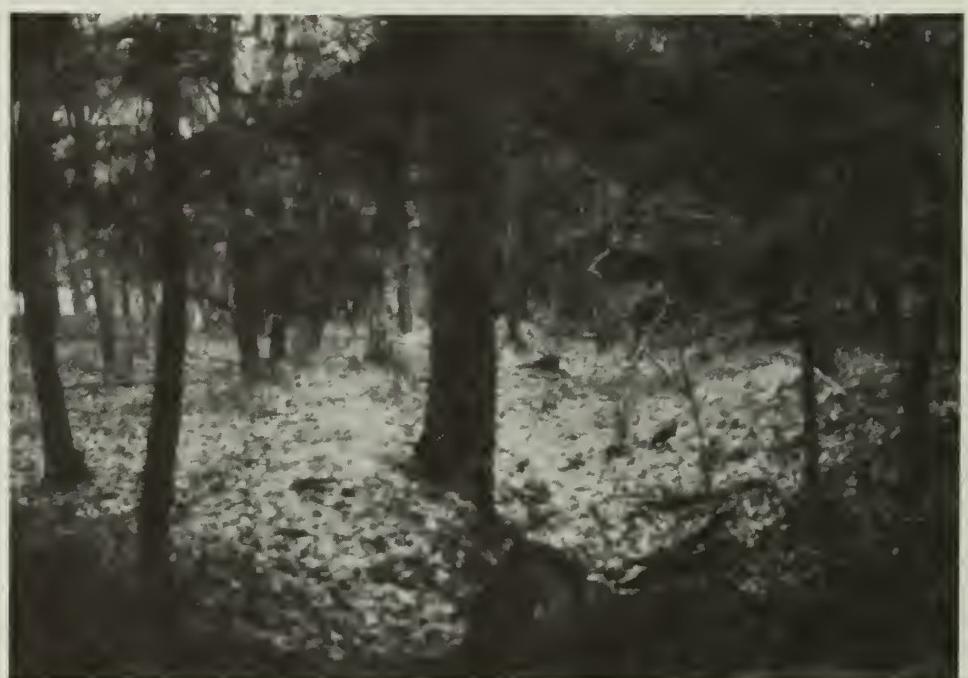
Figure 6C Photo 20
1947-1862 period spoil pile at trench 7

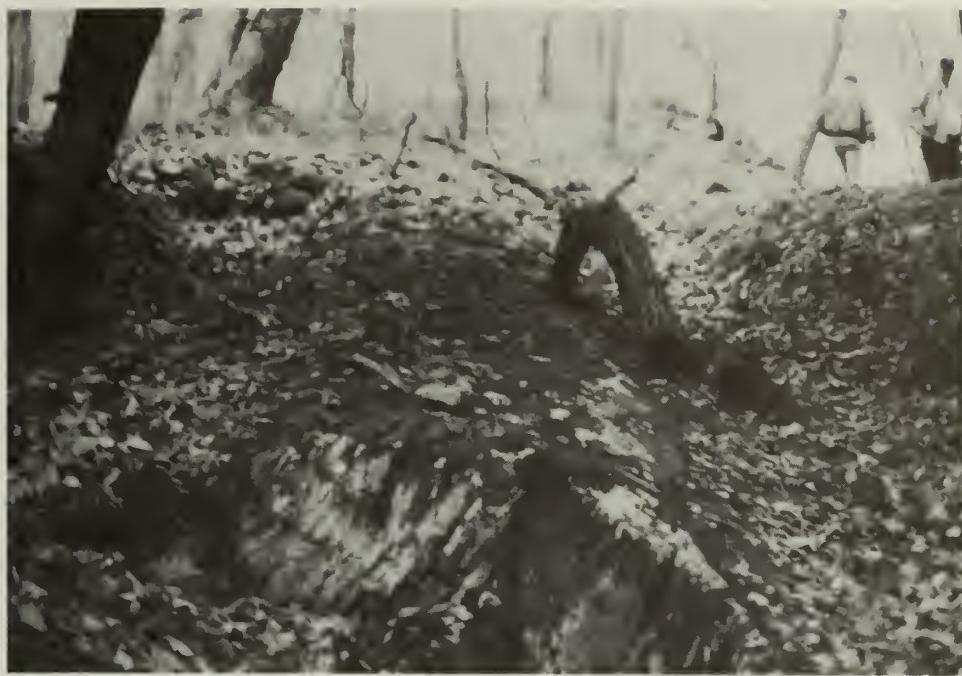
Figure 6C Photo 21
1847-1862 period trench number 7

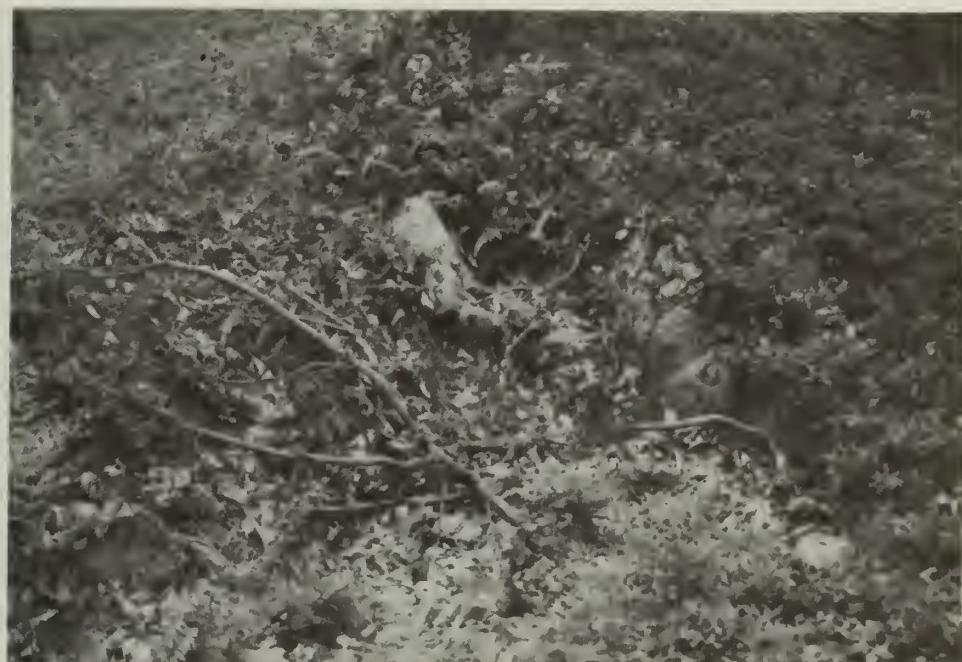
Figure 6C Photo 22
1847-1862 period "elephants back" workings number 8

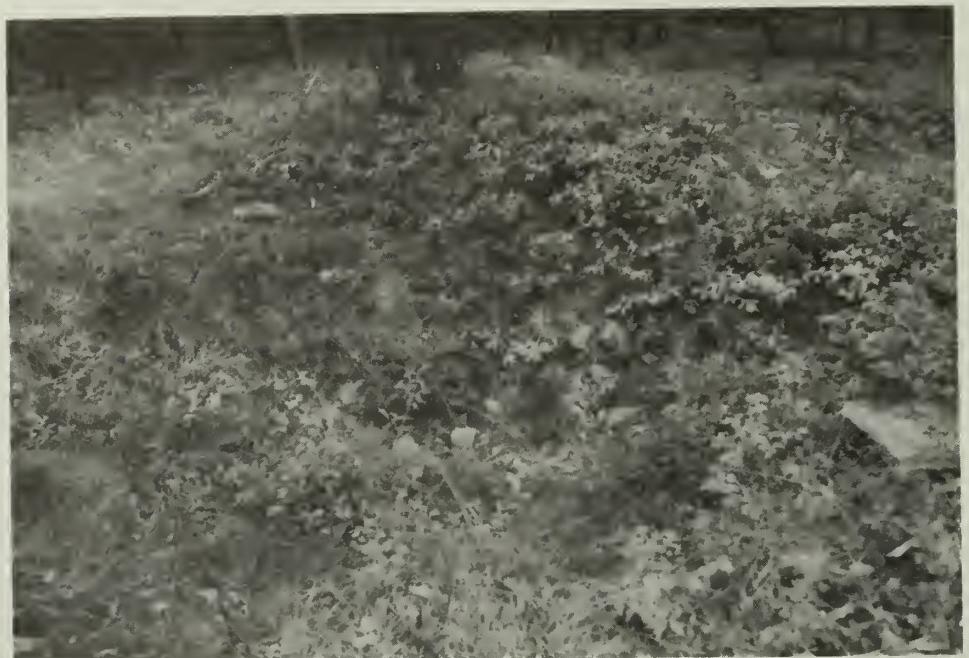
Figure 6C Photo 23
1847-1862 period prospect hole number 9

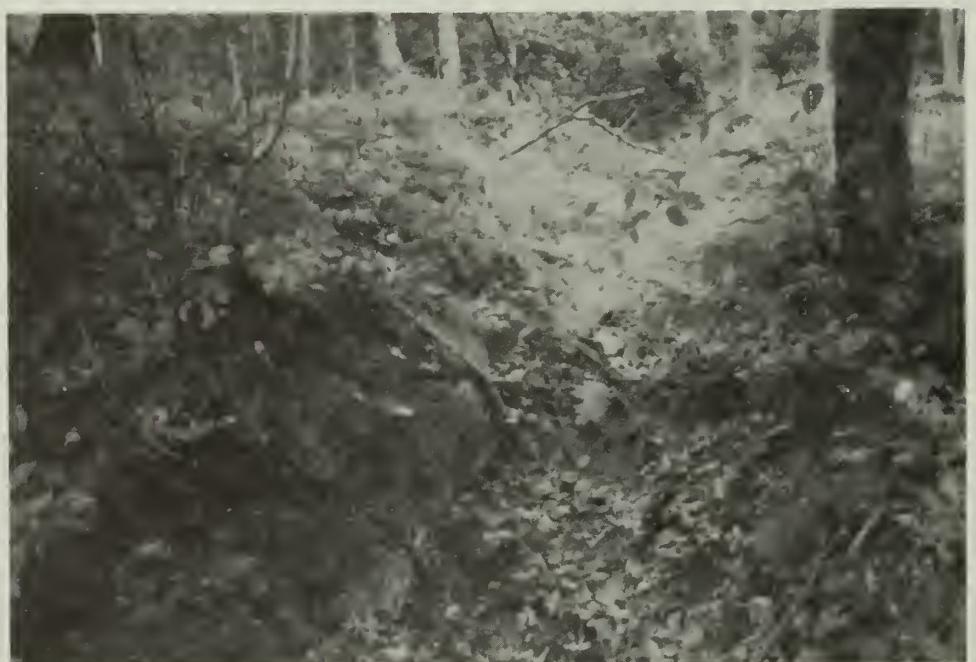
Figure 6C Photo 24
1847-1862 period prospect hole number 10

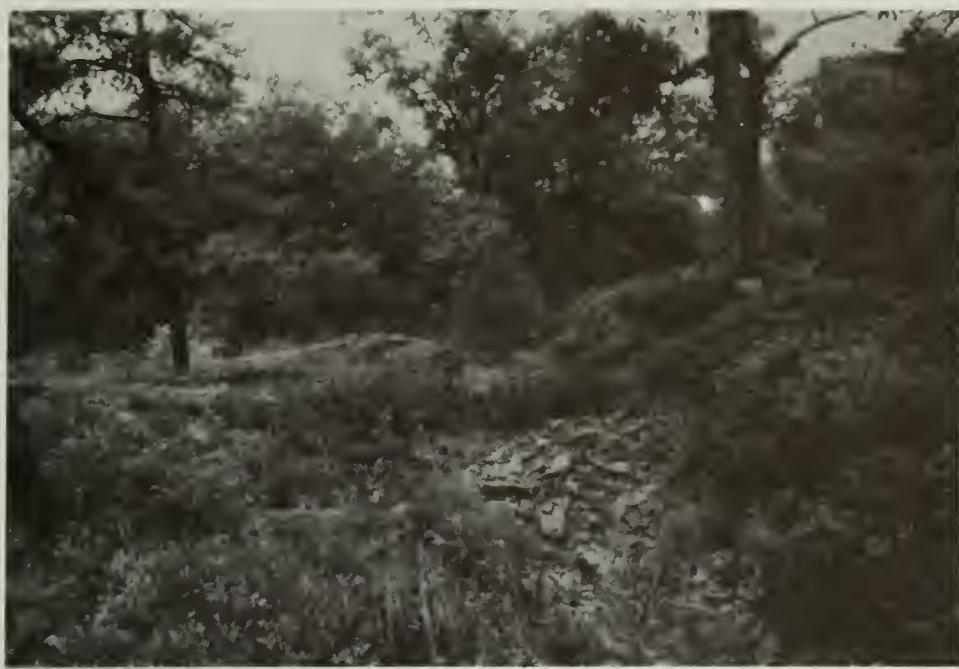
Figure 6C Photo 26
Unknown possible 1906 test trench south of adit number 10

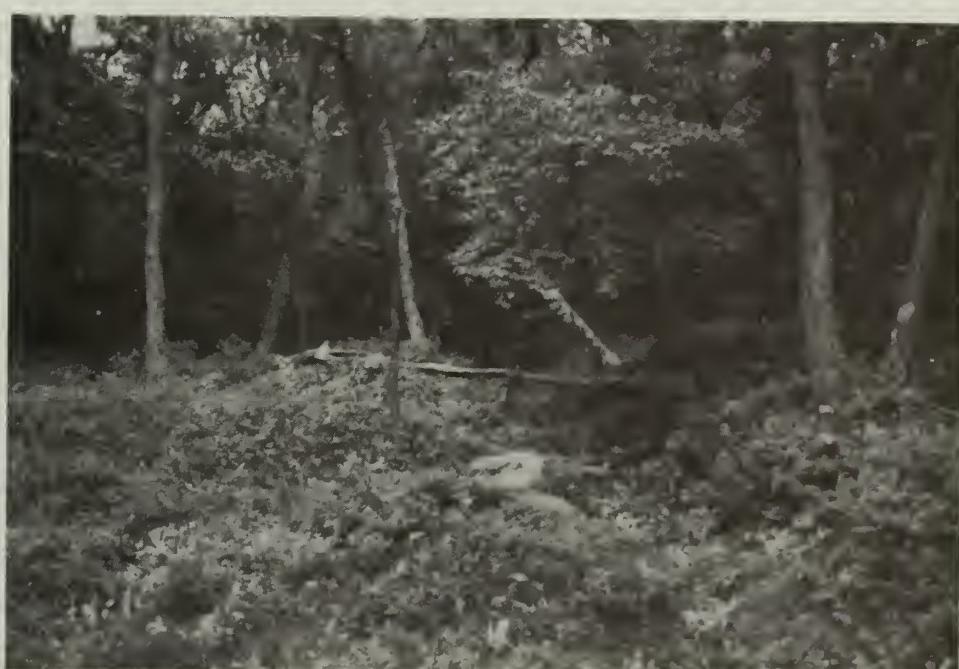
Figure 6C Photo 27
Unknown probably begun in 1862 and reworked in 1901-1912 period very long test trench

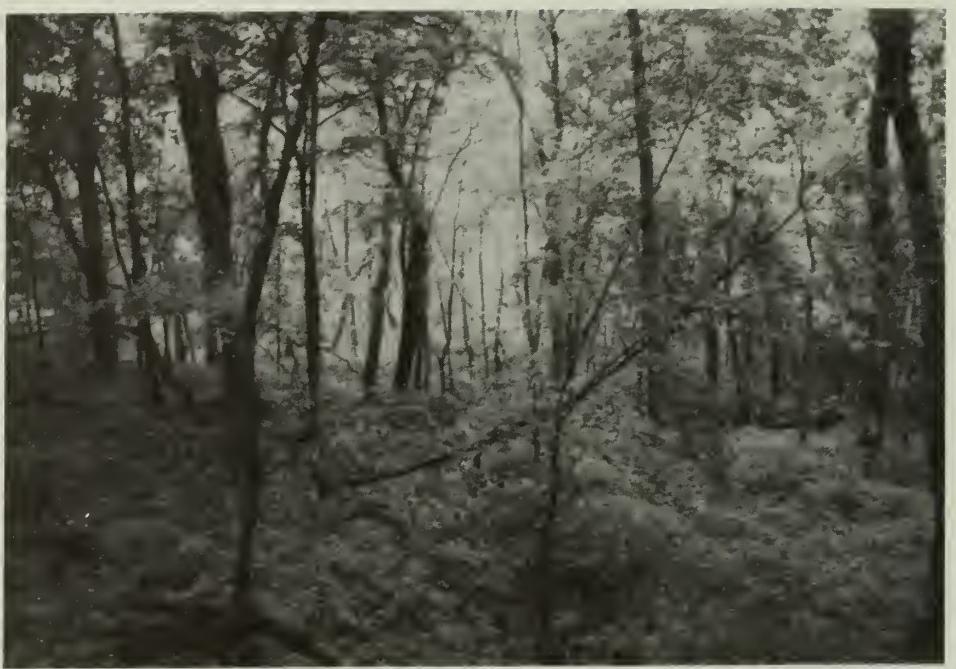
Figure 6C Photo 28

Unknown probably begun in 1862 and reworked in 1901-1912 period very long test trench looking northwest

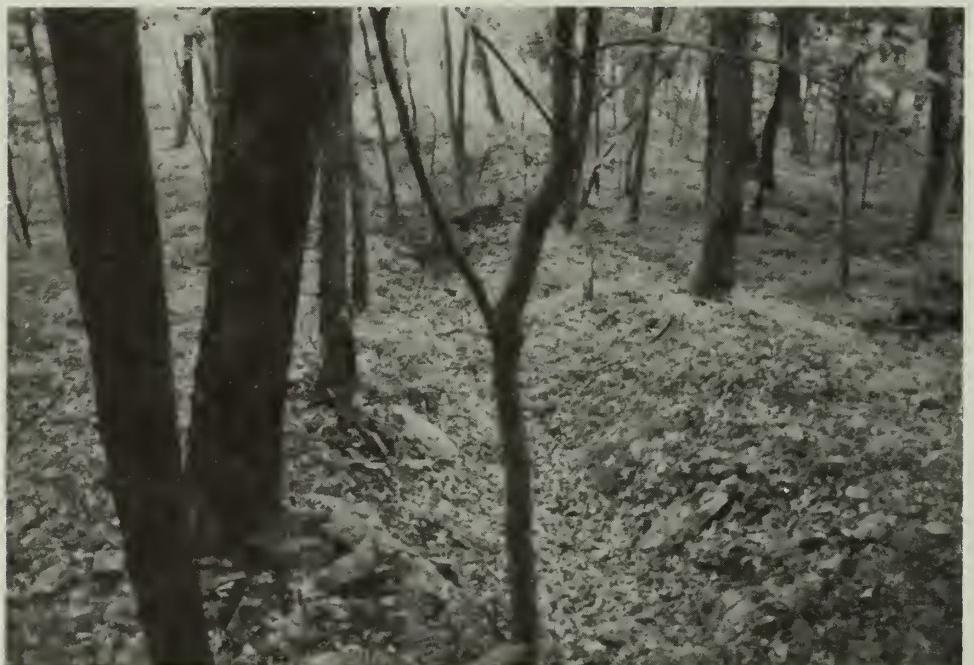
Figure 6C Photo 29

Unknown probably begun in 1862 and reworked in 1901-1912 period very long test trench looking northwest
